Manhole Inspection Summary

Manhole # S25C__006MH

Insp Date: **8/6/07 7:32 AM**

Location Address: **1044 FRANKLIN ST**

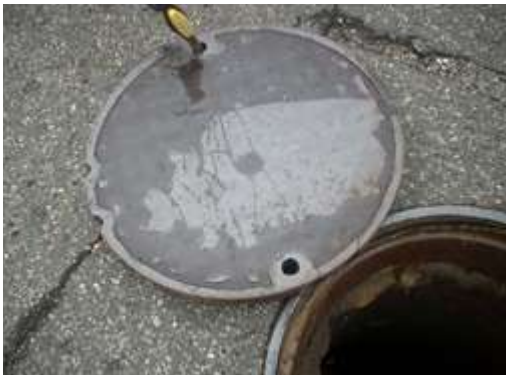
Defect 4

Condition: **Worn**

WORN COVER

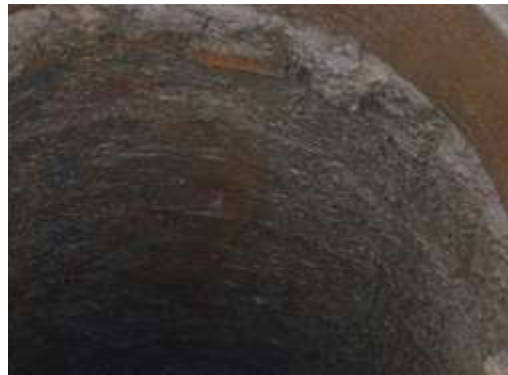
Defect 3

Infiltration: ☐ None ☐ Joint ☐ Cracks ☐ Mortar ☐ Roots ☒ **Wall**

INFILTRATION OF CHIMNEY

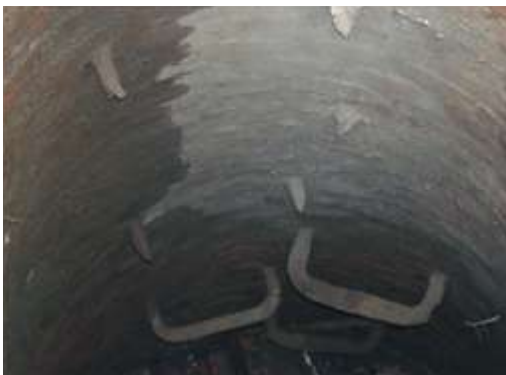
Defect 2

Count: **3** Missing: **3** ☒ **Corroded**

MISSING AND CORRODED STEPS

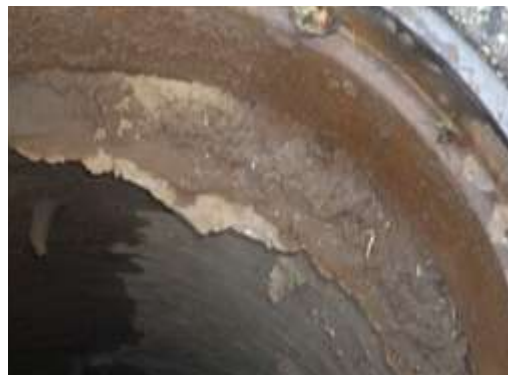
Defect 1

Offset: **2** (in.)

FRAME OFFSET

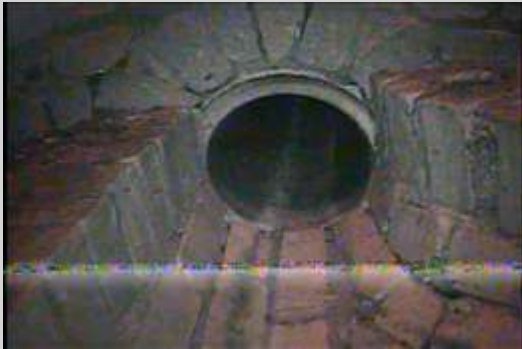
12 O'Clock Outflow

Pipe Height: **8.4** (in.) Rod and Bar (Angled)
Pipe Material: **Clay** ☐ Pipe Lined
Invert Depth: **11.21** (ft.) Flow Characteristics: **Slow**
Deposits: ☒ None ☐ Mud ☐ Sludge ☐ Debris ☐ Grease
Silt Depth: (in.) Deposits Extent:
Infiltration: **None** Pipe Seal Cond: **Sound**

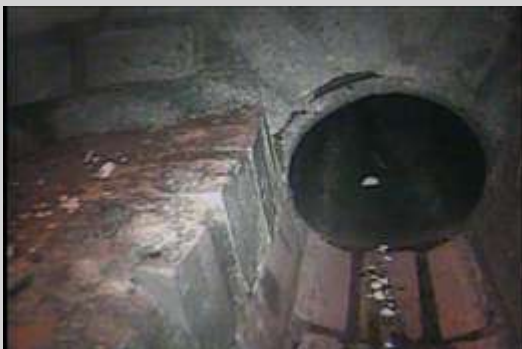
3 O'Clock Inflow

Pipe Height: **8.4** (in.) Rod and Bar (Angled)
Pipe Material: **Clay** ☐ Pipe Lined
Invert Depth: **10.81** (ft.) Flow Characteristics: **Slow**
Deposits: ☒ None ☐ Mud ☐ Sludge ☐ Debris ☐ Grease
Silt Depth: (in.) Deposits Extent:
Infiltration: **None** Pipe Seal Cond: **Sound**

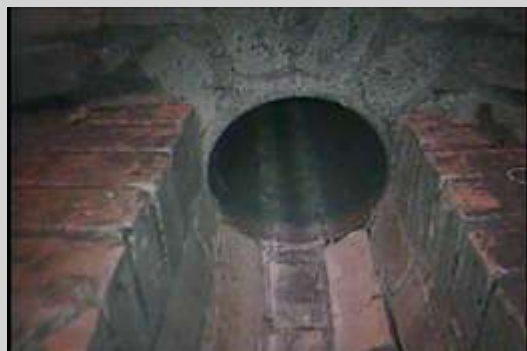
6 O'Clock Inflow

Pipe Height: **8.4** (in.) Rod and Bar (Angled)

Pipe Material: **Clay** ☐ Pipe Lined

Invert Depth: **10.83** (ft.) Flow Characteristics: **Slow**

Infiltration: **None** Pipe Seal Cond: **Sound**
